## Results of the 2007 Cottonwood Creek Video Station Fall-Run Chinook Salmon Escapement

By  
Douglas Killam  
California Department of Fish and Game, Northern Region  
Sacramento River Salmon and Steelhead Assessment Project

SRSSAP Technical Report No. 08-3  
2008

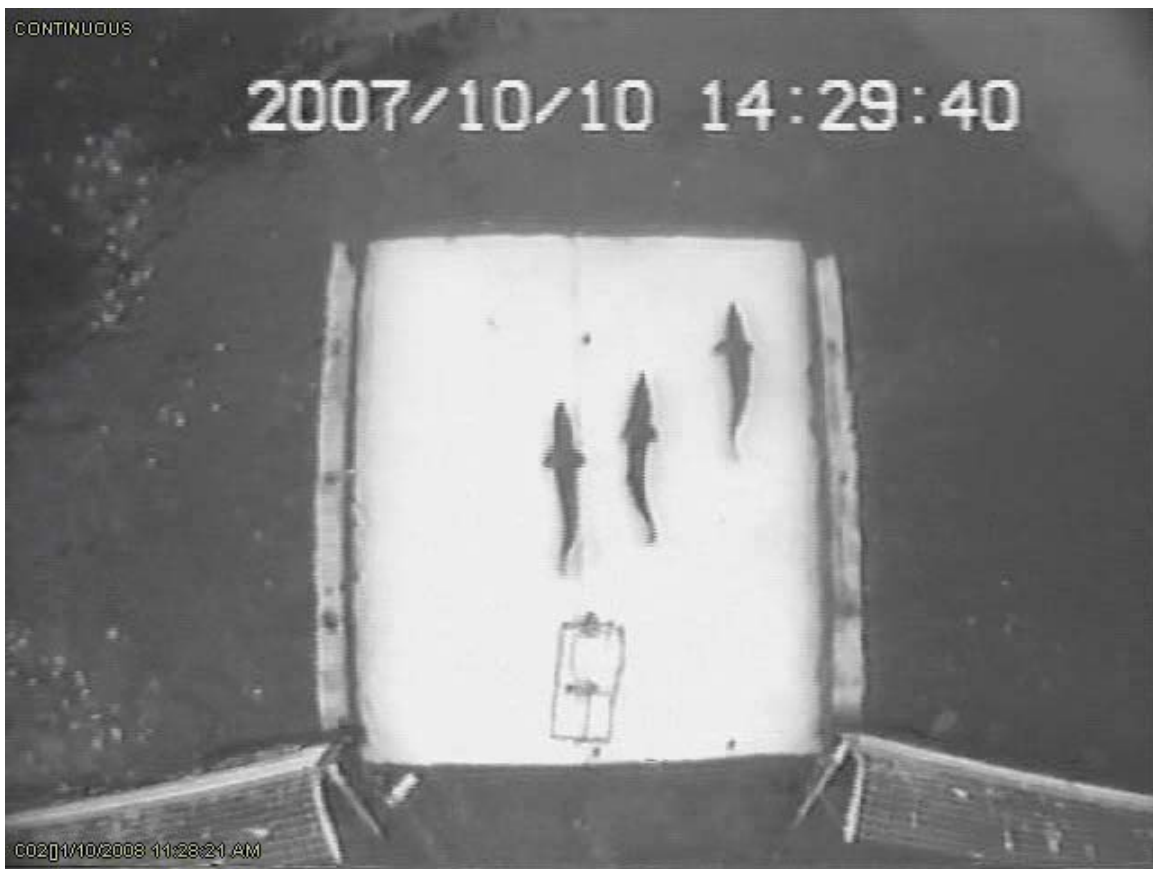
*Cover Photo: View from the overhead camera looking down on the fish passage opening  
of the 2007 Cottonwood Creek Video Station*

White high density polyethylene (HDPE) sheets were staked to the creek bottom to make the observation of passing salmon easier. Two overlapping ¼ inch by 4 by 10 feet (6 mm x 1.2 m x 3 m) sheets were used to create a white background (see report cover photo).

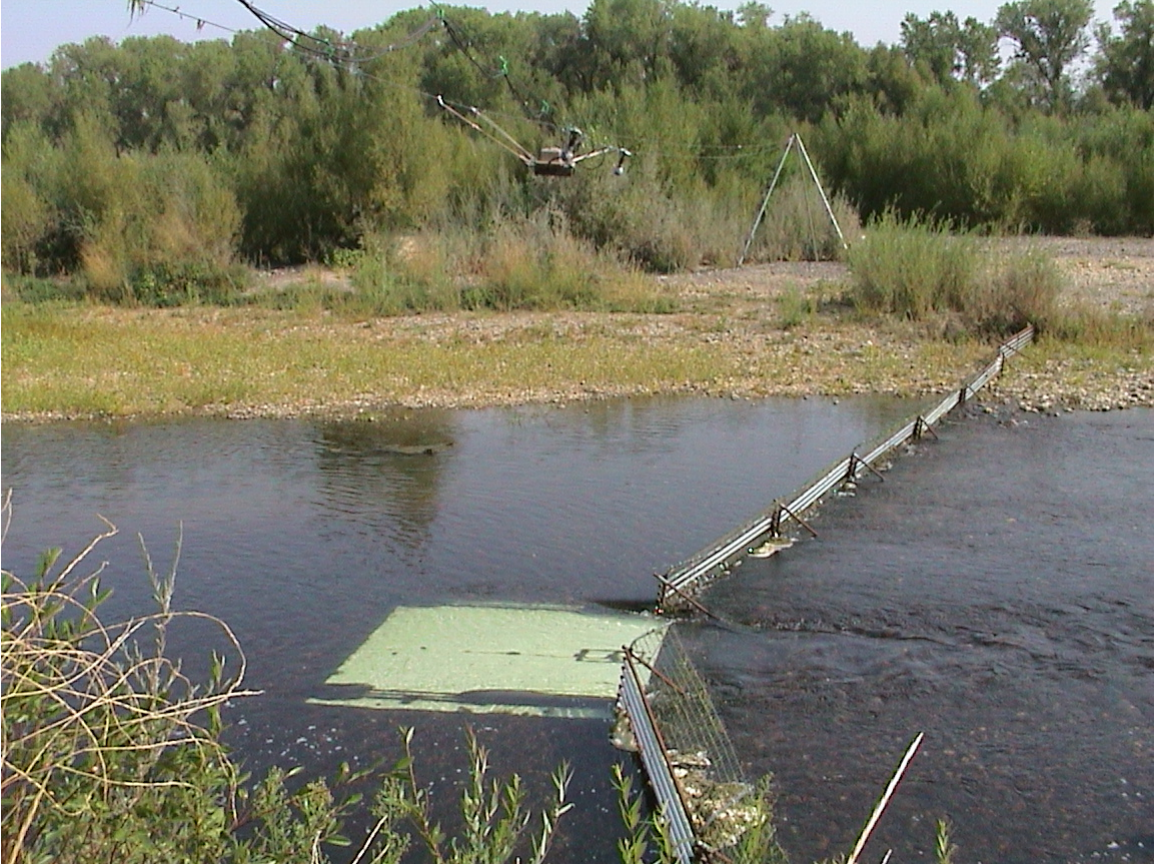
*Figure 2. Video station camera box, lights, weir and passage opening with white plates visible. Camera is suspended from two overhead cables which are anchored to riparian trees and to a tall pipe tripod. Inside camera box is wiring junctions for electrical and video systems, and photo cell to turn lights on at dusk.*

The camera box, (shown in Figure 2), was suspended over Cottonwood Creek at a height of about 15-feet (4.6 m) from the water’s surface using a cable system constructed of 5/16-inch (7.9 mm) galvanized steel cables. The cable system consisted of two main cables. The two main cables, about 300-feet (91.4 m) each, were stretched across the creek and anchored in trees on one side of the creek and a welded tripod (Figure 2 background) on the other side. The tripod was constructed from 2.5 inch (6.3 cm) galvanized metal pipe, and anchored in place using fence posts driven into the ground and cabled to the legs of the tripod. The design of the cable system prevented side-to-side sway which allowed fish counting in all wind conditions. Tightening of the main cables was accomplished with a mechanical “come-along”. The end of the main cable closest to the campground was designed to allow easy movement up and down with an hand operated “come-along”. In this manner the camera was raised and lowered if an adjustment to lighting, or camera cleaning was required.

Two weir panels were added as upstream facing guidance panels along the fish passage opening to prevent fish from skirting around the ends of the weir (visible in Figure 2). These guidance panels were placed along the outside edges of the white bottom plates just under the water surface and resulted in most fish swimming upstream along the entire length of the plates allowing for easier counting compared to similar weirs without these guidance panels (e.g. Battle Creek in 2003, (Killam 2006)).
